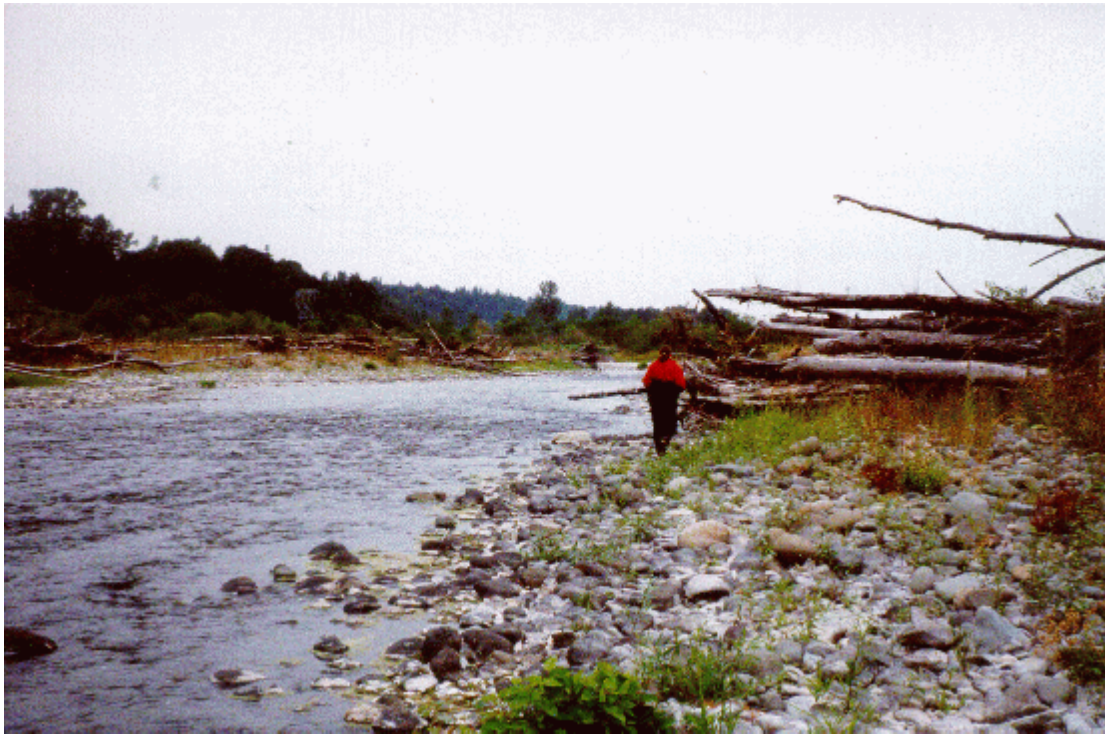
Figure 3-8: Naturally reclaimed riffle habitat on July 31, 2001, at the site of the historical 1996 avulsion into Ridgefield Pit 1 on the East Fork Lewis River. The pool, which remains, is to the right of the photo behind the new channel bank.

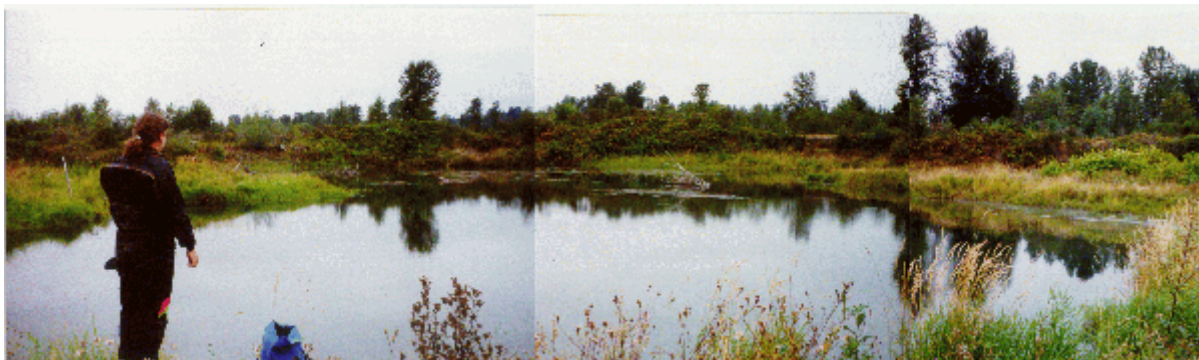
Figure 3-9: Panoramic view of Ridgefield Pit 1 on July 31, 2001, which has reverted to off-channel habitat after five years of natural deposition. The main channel of the East Fork Lewis River is behind the viewer and is connected via a backwater slough-like channel.
